CHARACTERIZATION OF FATIGUE BEHAVIOR  
OF 2-D WOVEN FABRIC REINFORCED  
CERAMIC MATRIX COMPOSITE  
AT ELEVATED TEMPERATURE

THESIS

Daniel J. Groner, Captain, USAF

AFIT/GAE/ENY/94D-15

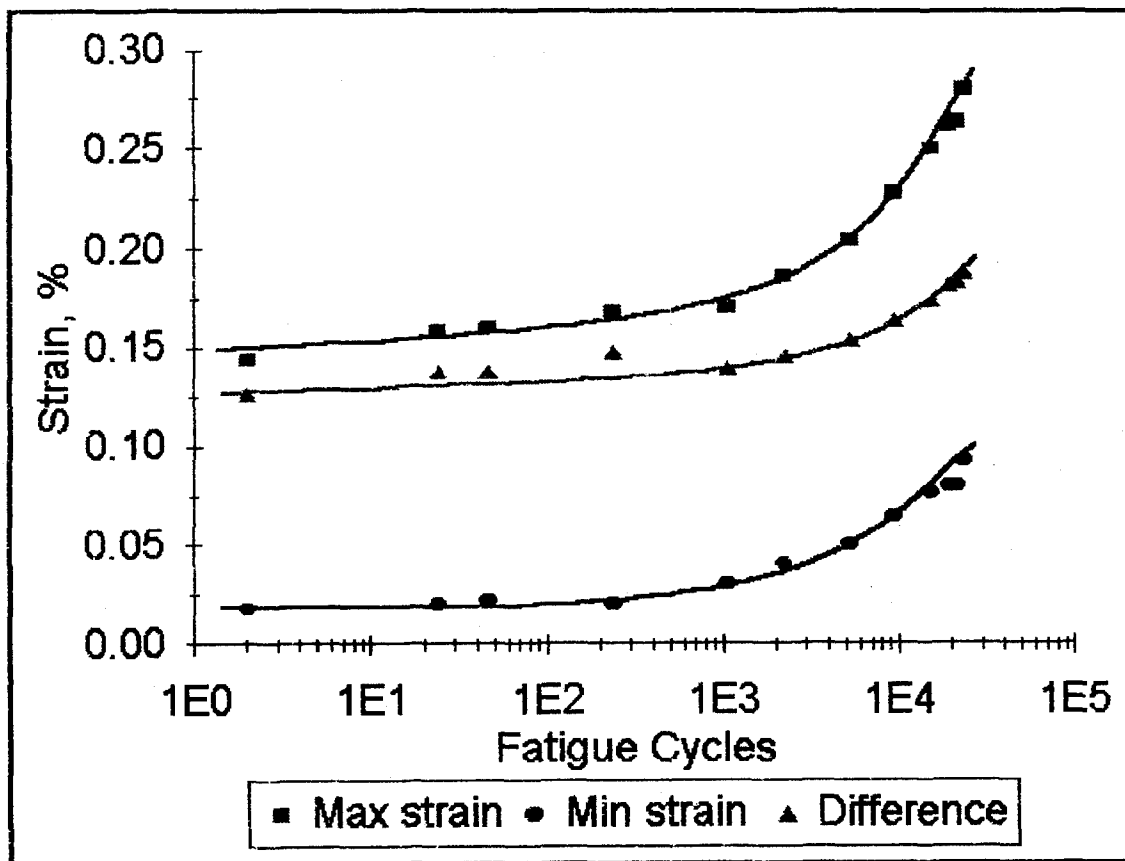
Figure 4-51 Strain Behavior of Unnotched Specimens at a Maximum Stress of 140 MPa

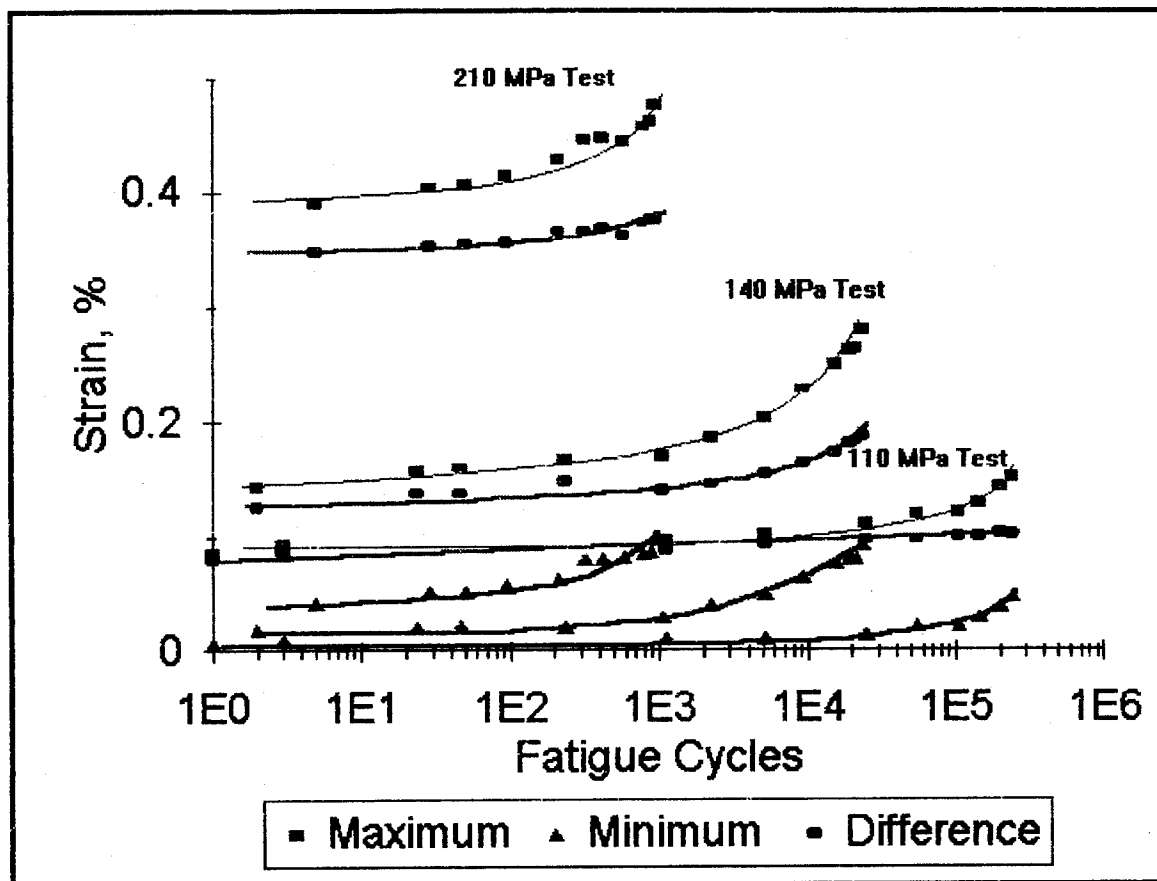
Figure 4-52 Strain Behavior of Unnotched Specimens at Three Load Levels

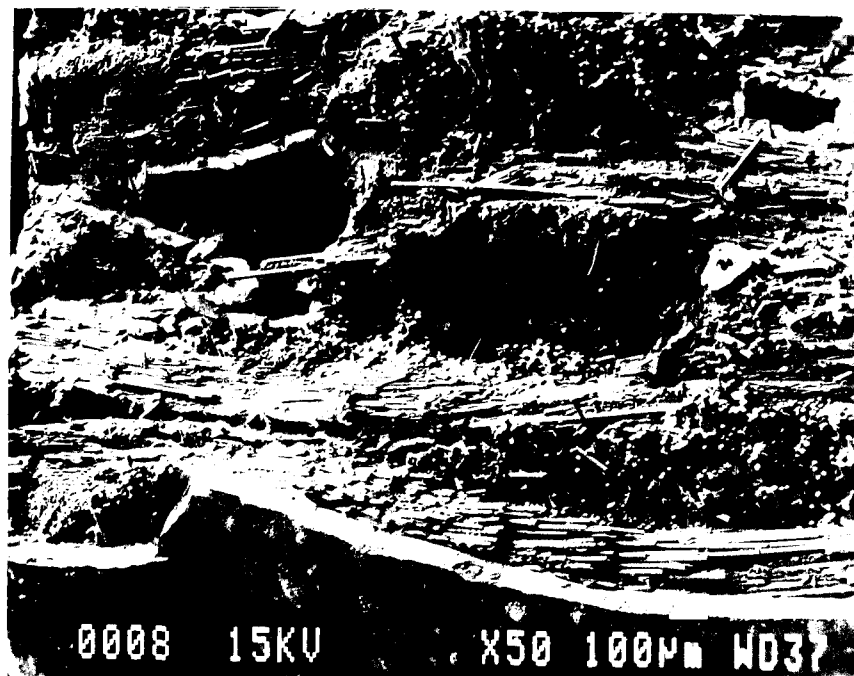
Figure 4-54 Unnotched Fracture Surface, 120 MPa Test, 50X

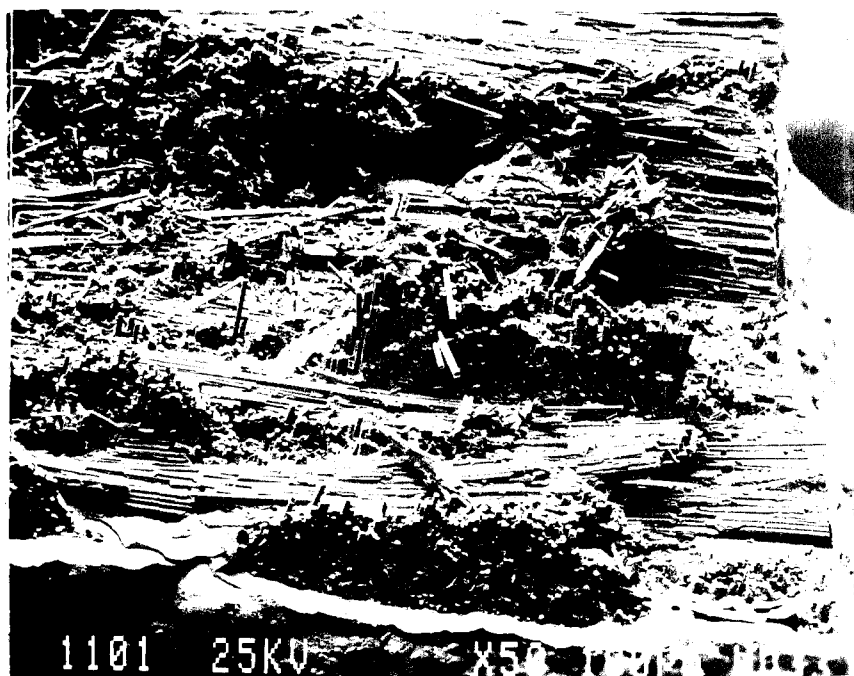
Figure 4-55 Notched Fracture Surface, 110 MPa Test, 50X

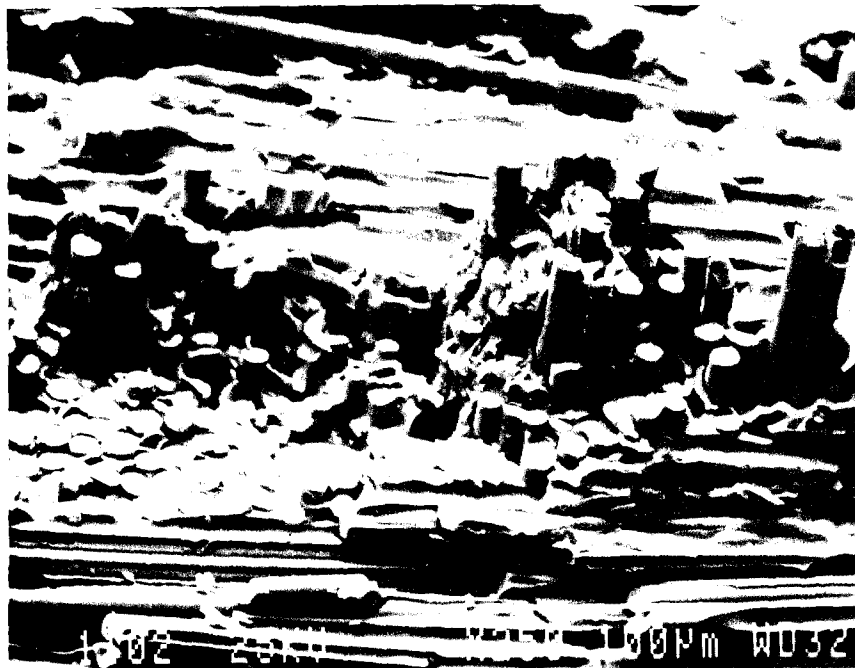
Figure 4-56 110 MPa Notched Specimen, Micrograph of Fracture Near Hole, 250X

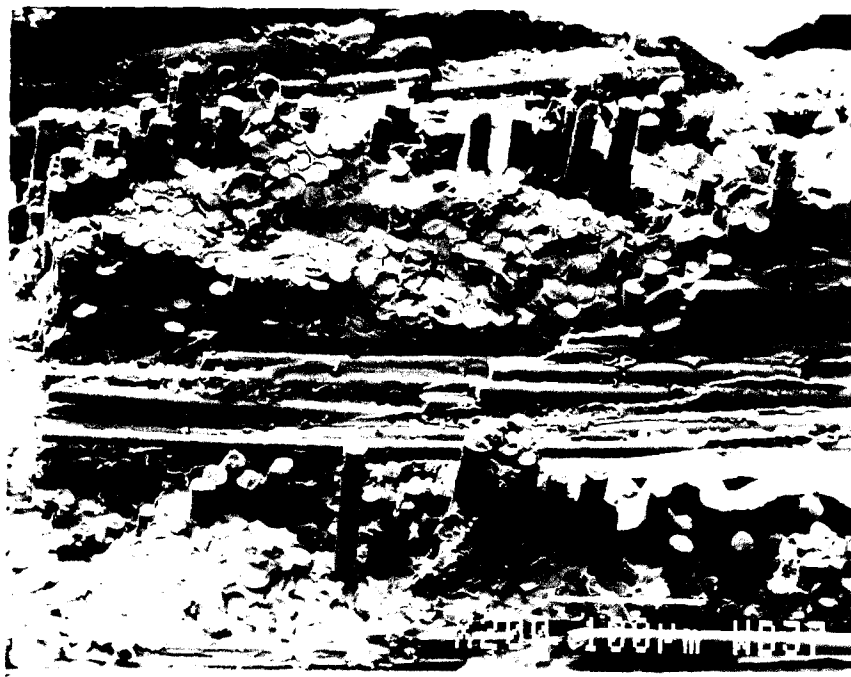
Figure 4-57 110 MPa Unnotched Specimen, Micrograph of Fracture Near Edge, 200X

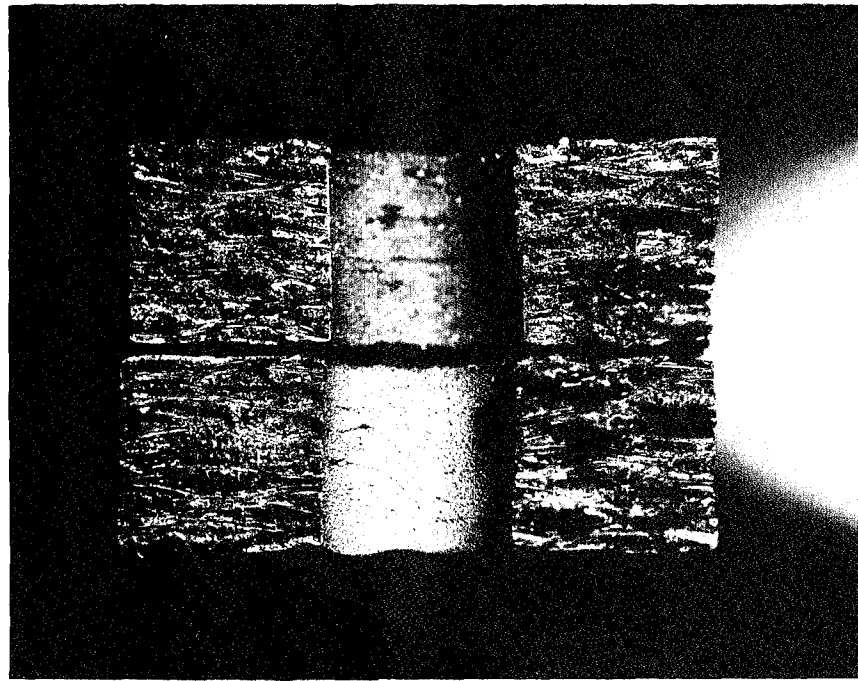
Figure 4-59 Micrograph Comparison, Notched Specimen Fracture, 8X, 110 MPa (top) 190 MPa (bottom)

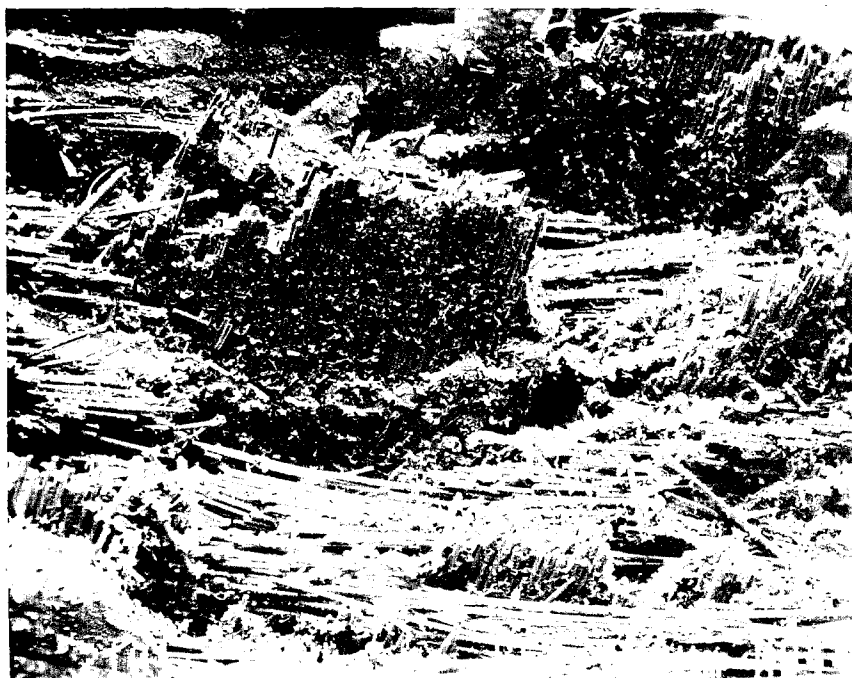
Figure 4-60 Unnotched Fracture Surface, 210 MPa Test, 50X Mag.

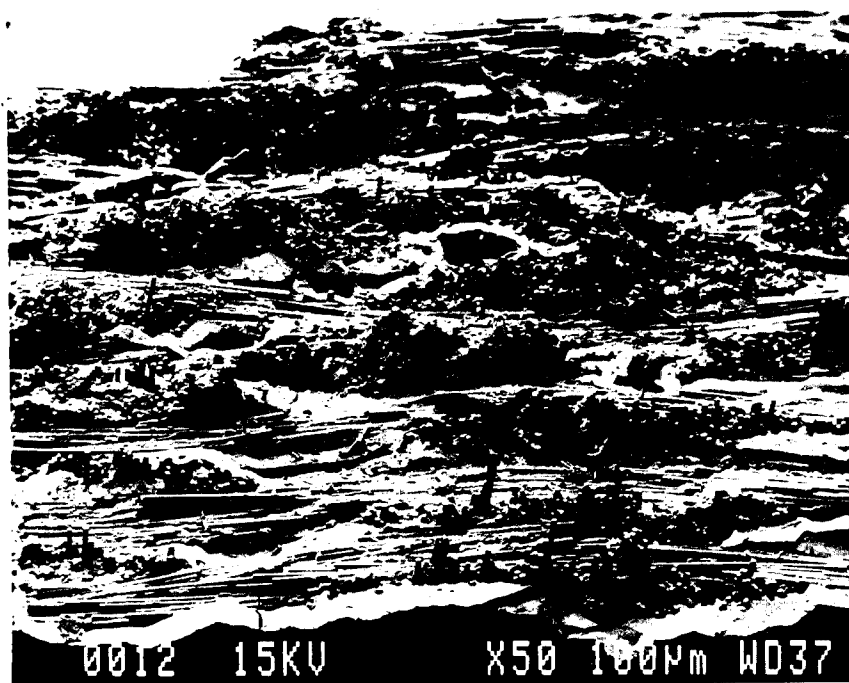
Figure 4-61 Unnotched Fracture Surface, 110 MPa Test, 50X Mag.

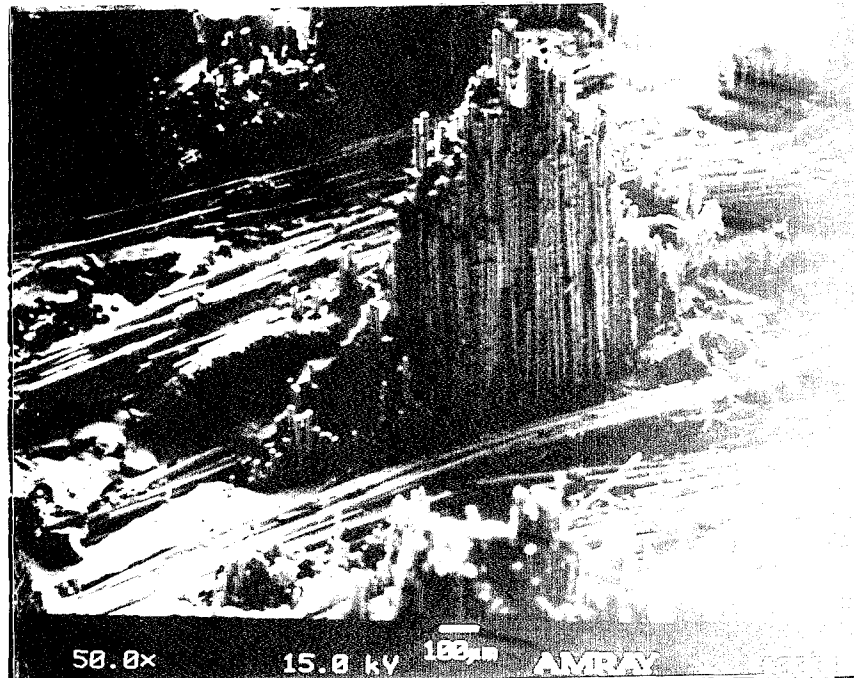
Figure 4-62 Fracture Surface, Notched Monotonic Tensile Test, 50X Mag.

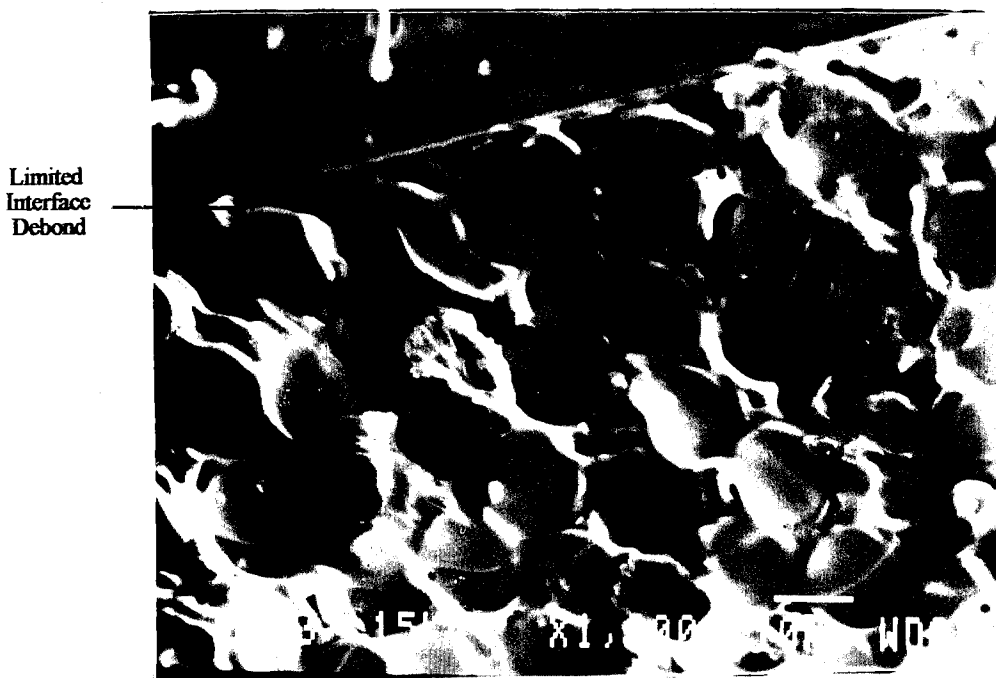
Figure 4-63 Micrograph of 0° Fiber Breakage, 110 MPa Unnotched Test, 1000X

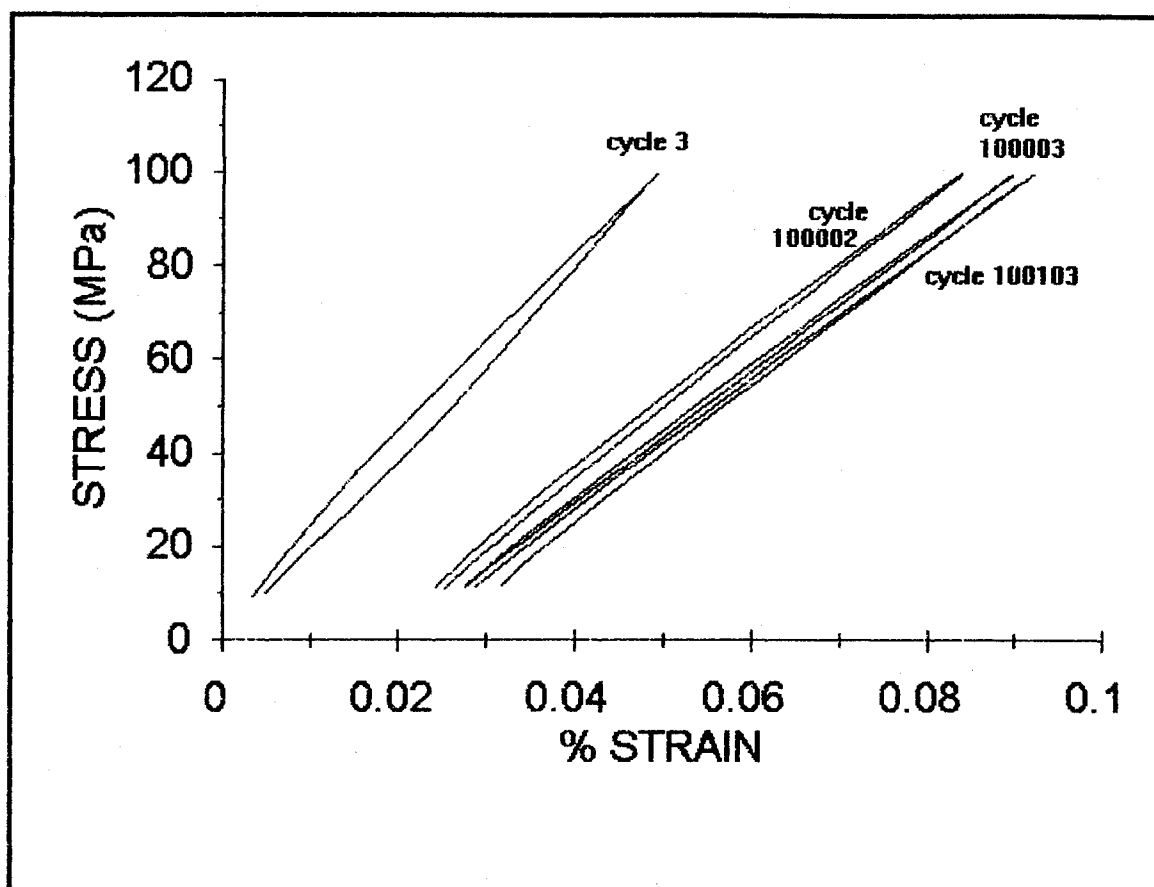
Figure B-4 Stress-strain, 100 MPa Notched Test
